Phase I Environmental Site Assessment

Vacant 59.6-Acre Parcel
Maui Lani Development Site
Kahului, Maui, Hawaii

Clayton Project No. 85-05247.00
April 26, 2005

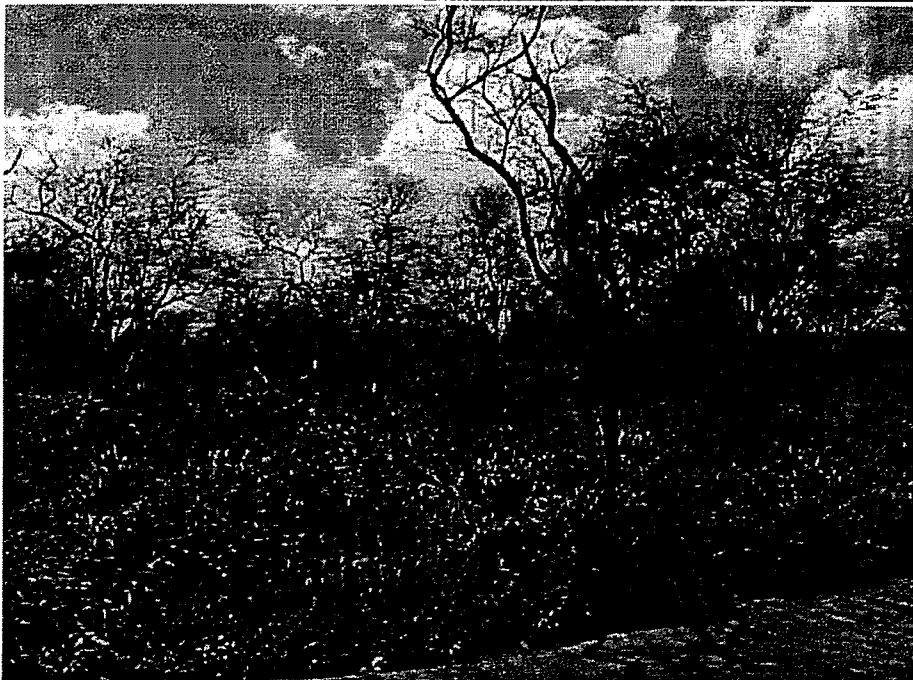
- Fugitive dumping of refuse materials, consisting of trash and miscellaneous paint containers, were observed to the north of the subject property, near a yard area adjoining a house site. The house is currently being used as a temporary storage site for historical artifact collection and preservation.
- Waikapu Landfill and Wailuku Baseyard were listed in the Hazard Evaluation and Emergency Response (HEER) database for soil contamination issues and the statuses for these sites remain currently open. However, based on Release Notifications provided by HEER Office, both of the releases were issued “no further action” determinations. Therefore, these releases are unlikely to impact the subject property.

Clayton Project Number 85-05247.00	Description	View of the adjacent property located to the north of the subject property, looking north	Photo 8
	Site Name	59.6 acres at Maui Lani Development, Kahului, Maui, Hawaii	Photo Date
	Client	Maui Lani Partners	02/28/05

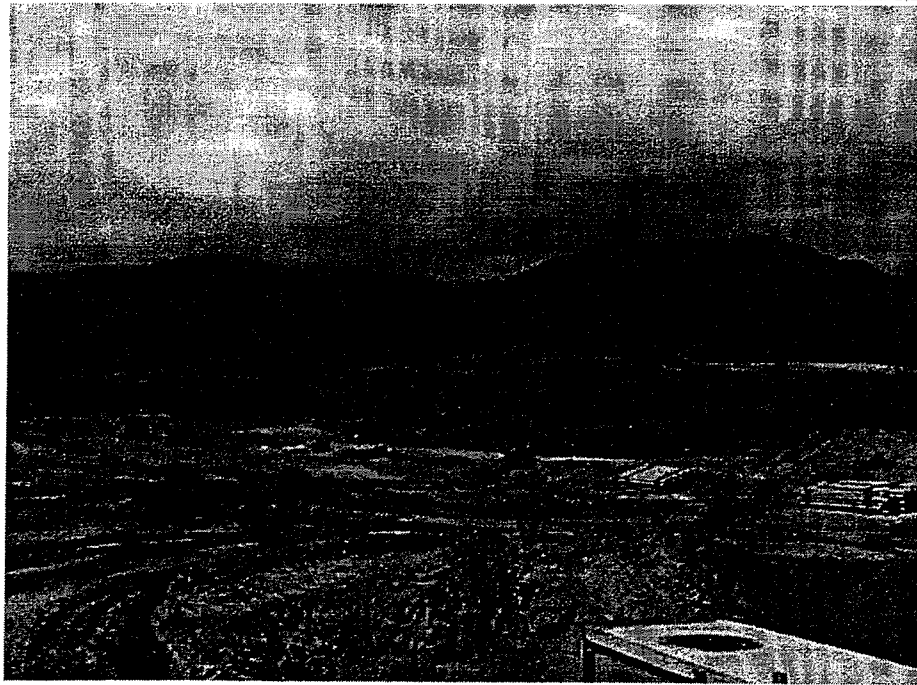
Clayton Project Number 85-05247.00	Description	View of road development located to the east of the subject property	Photo 11
	Site Name	59.6 acres at Maui Lani Development, Kahului, Maui, Hawaii	Photo Date
	Client	Maui Lani Partners	02/28/05

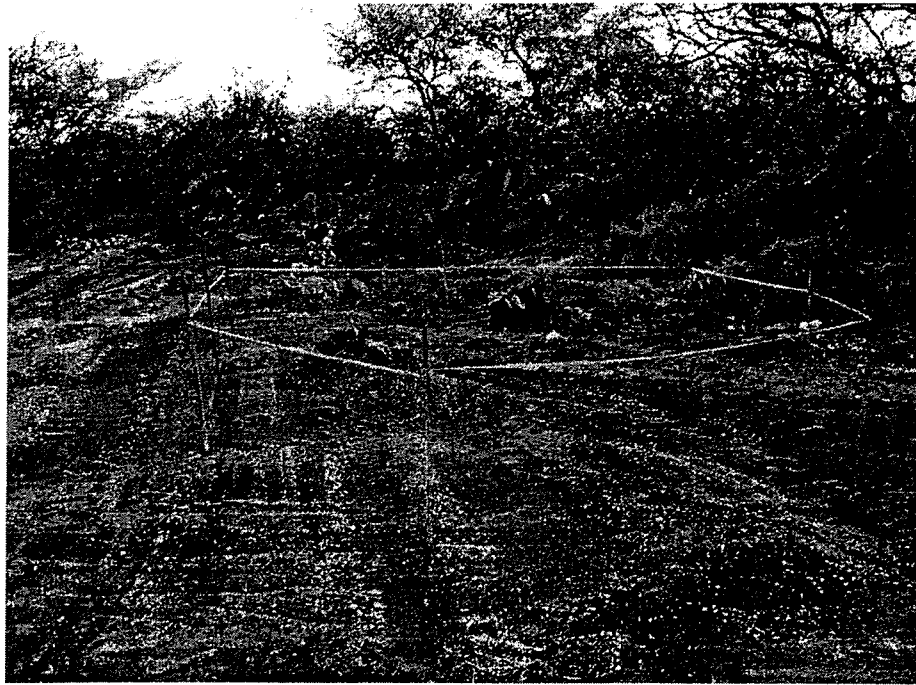
Clayton Project No. 85-05246.00	Description	Release location prior to excavation	Photo 1
	Site Name	Release Response for Maui Lani Development Site	Photo Date 04/05/05
	Client	Maui Lani Partners

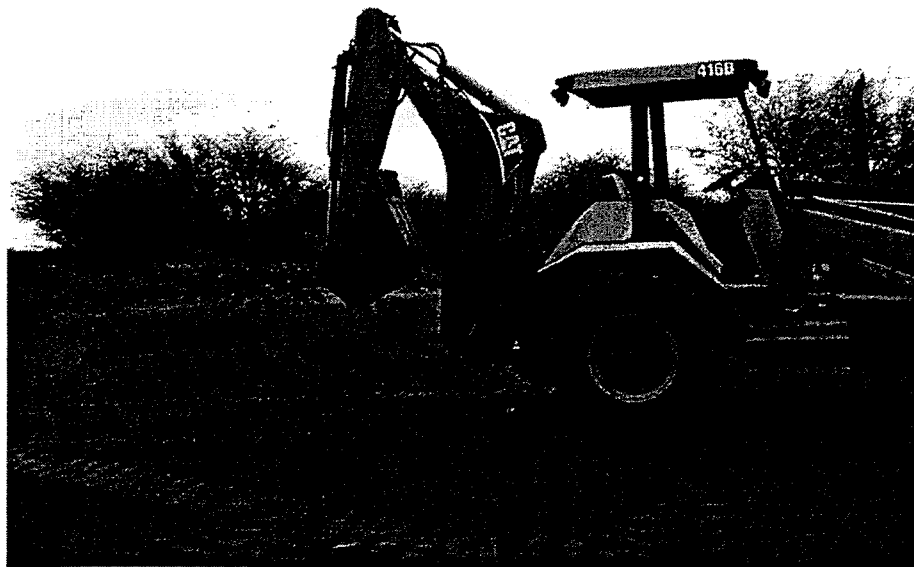
Clayton Project No. 85-05246.00	Description	Equipment used to excavate	Photo 2
	Site Name	Release Response for Maui Lani Development Site	Photo Date 04/05/05
	Client	Maui Lani Partners

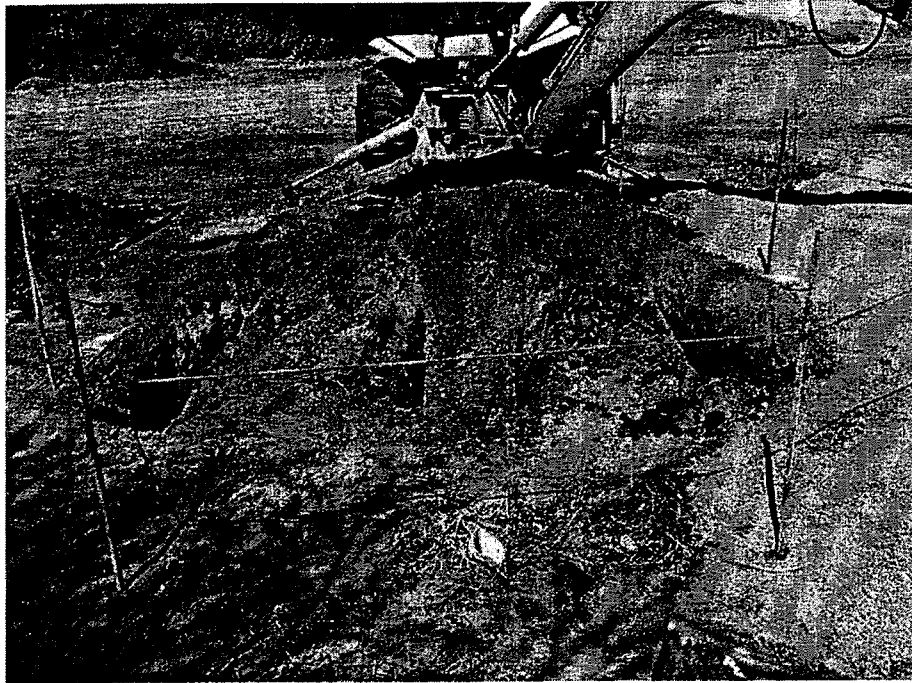
Clayton Project No. 85-05246.00	Description	Overview of excavated tests pits	Photo 3
	Site Name	Release Response for Maui Lani Development Site	Photo Date 04/05/05
	Client	Maui Lani Partners

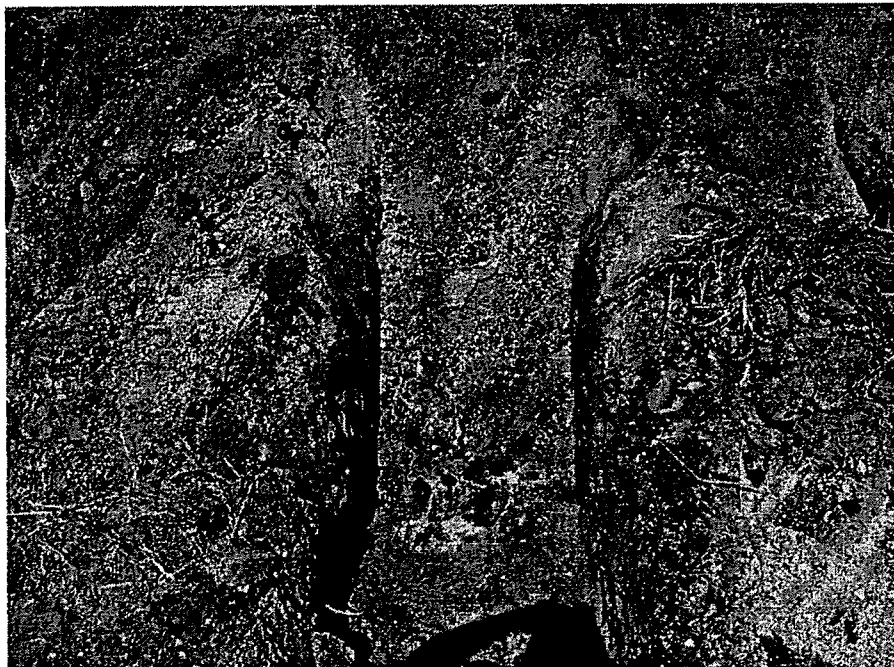
Clayton Project No. 85-05246.00	Description	Test pit 1	Photo 4
	Site Name	Release Response for Maui Lani Development Site	Photo Date 04/05/05
	Client	Maui Lani Partners

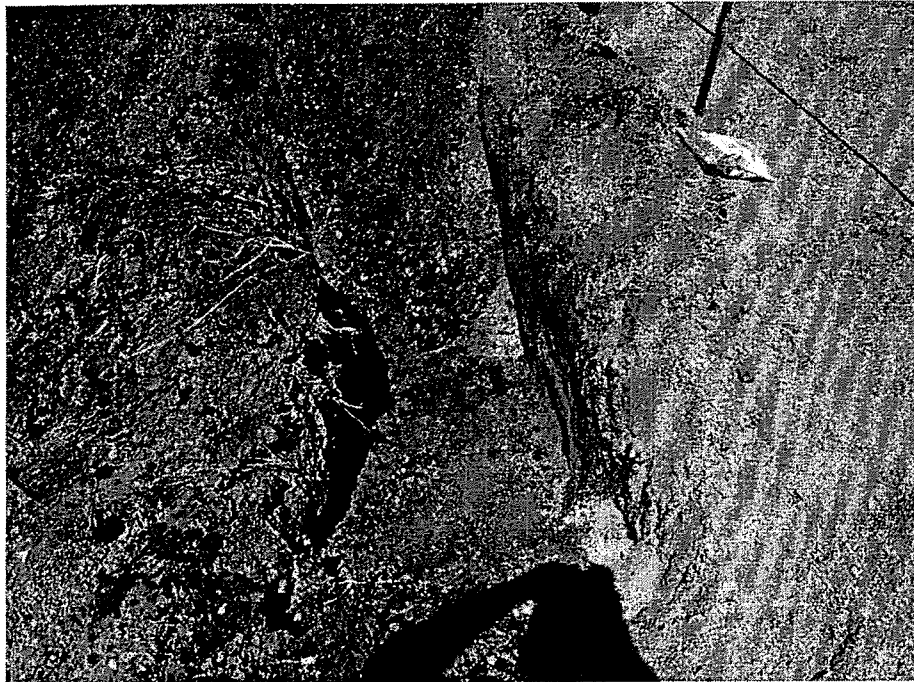
Clayton Project No. 85-05246.00	Description	Test pit 2	Photo 5
	Site Name	Release Response for Maui Lani Development Site	Photo Date 04/05/05
	Client	Maui Lani Partners

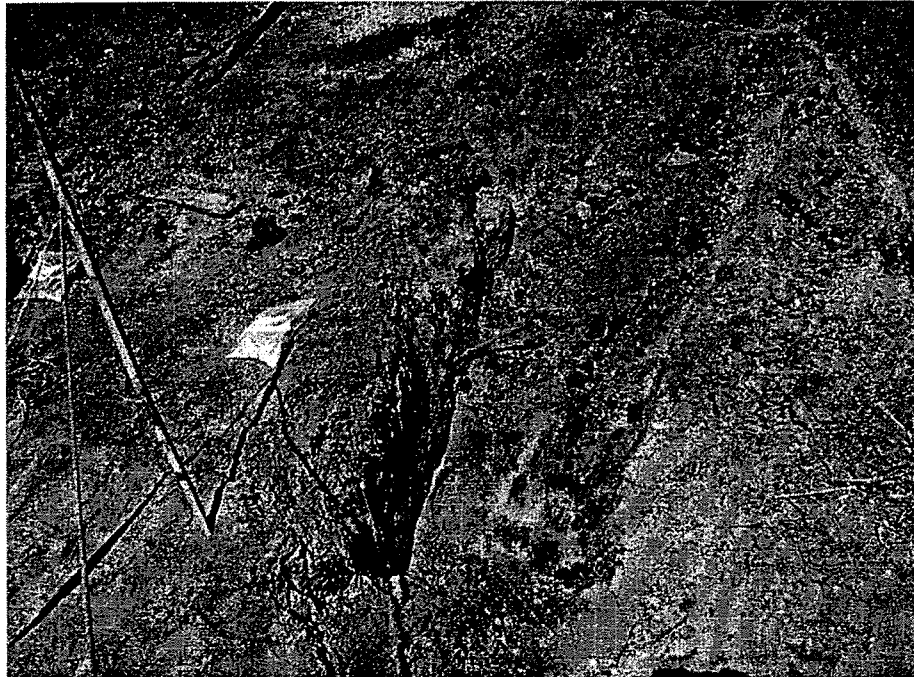
Clayton Project No. 85-05246.00	Description	Test pit 3	Photo 6
	Site Name	Release Response for Maui Lani Development Site	Photo Date 04/05/05
	Client	Maui Lani Partners

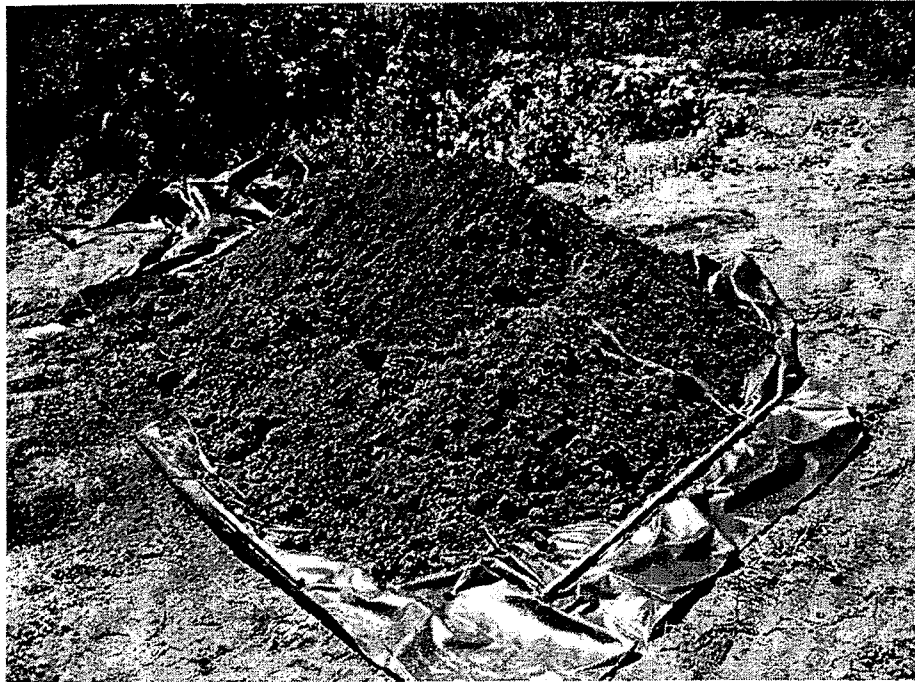
Clayton Project No. 85-05246.00	Description	Stockpile of soil excavated from test pits	Photo 7
	Site Name	Release Response for Maui Lani Development Site	Photo Date 04/05/05
	Client	Maui Lani Partners

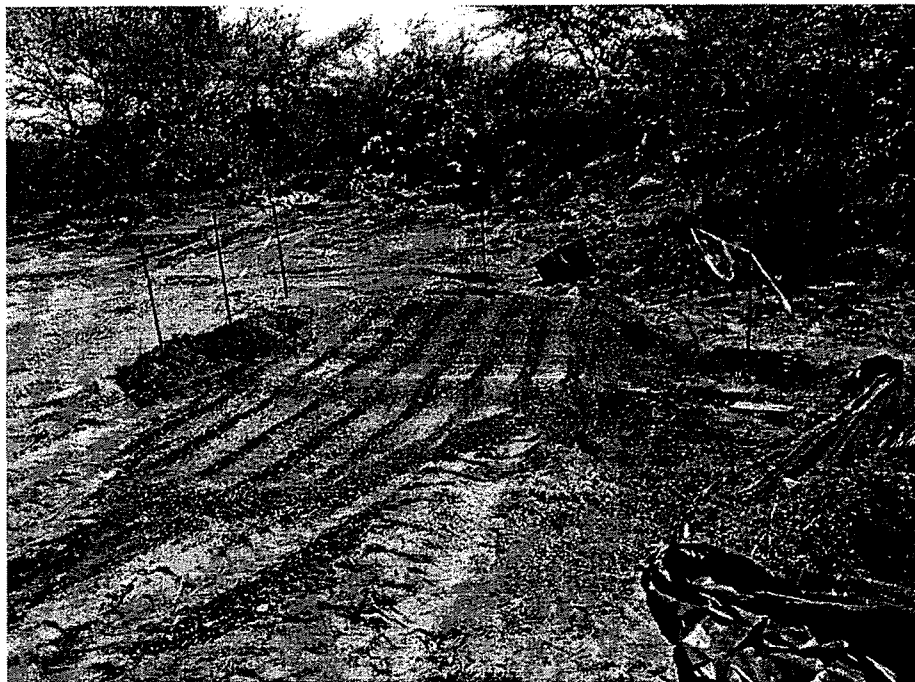
Clayton Project No. 85-05246.00	Description	Release site after backfilling test pits	Photo 8
	Site Name	Release Response for Maui Lani Development Site	Photo Date 04/05/05
	Client	Maui Lani Partners
